# REPORT ON A WELL AND WATER POLLUTION SURVEY

Village of Cannifton and  
North Sidney Street Area,  
Township of Thurlow

April, 1974

Ministry  
of the  
Environment

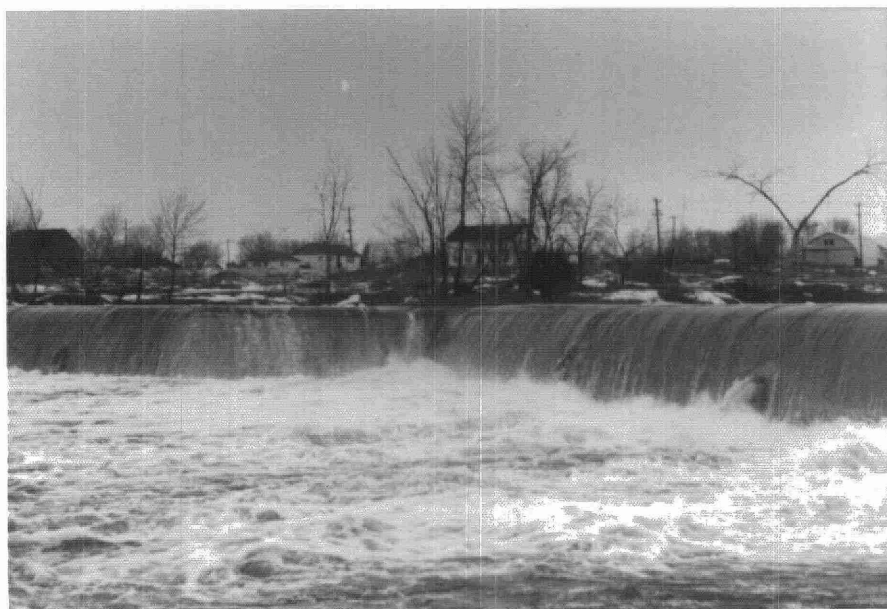
Falls located in the Moira River at Cannifton (January, 1974). Fairly high winter flow is evident.

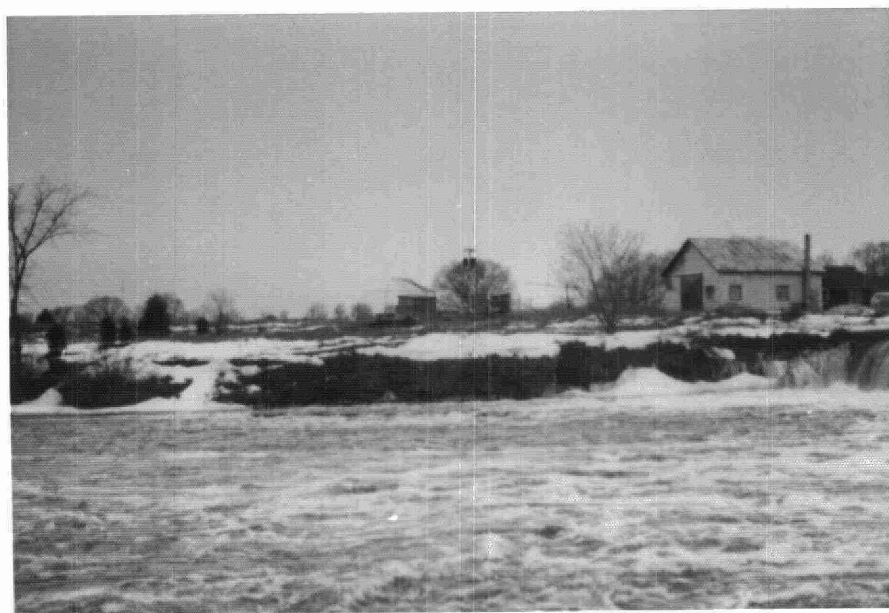
Photograph depicts characteristic landform features of the survey area.
